EIS - Preliminary Arborist Memorandum

To: Devin Byrd, University President, Bastyr University
Site: Bastyr University Campus, 14500 Juanita Dr NE, Kenmore, WA 98028
Re: EIS – Preliminary Arborist Memorandum
Date: April 7, 2025
Project Arborist: Katherine Taylor
ISA Certified Arborist PN-8022A
ISA Qualified Tree Risk Assessor
Reviewed By: Connor McDermott-Grossman
ISA Certified Arborist PN-8704A
ISA Qualified Tree Risk Assessor

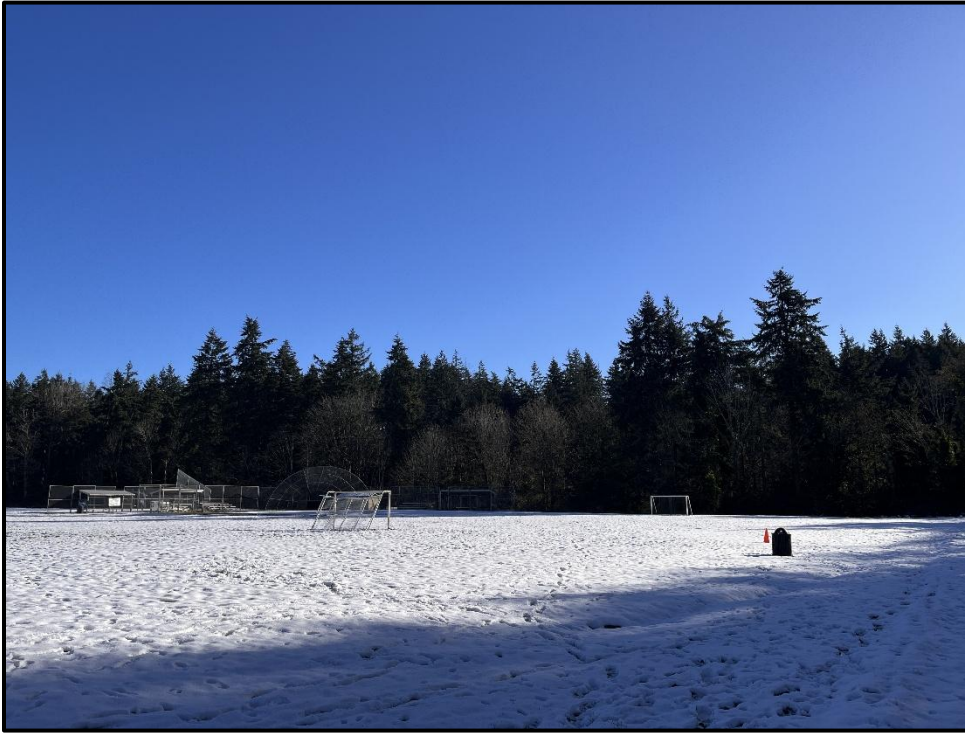
There are also edge trees connected to St. Edward State Park along the east and south side of what is currently a large open play field (Photo 1). These trees are mostly Douglas-fir and mixed broadleaf species including bigleaf maple and red alder (*Alnus rubra*).

targeted for retention. The forest edge trees to the east and south of the existing play field are also being targeted for retention. All of the trees proposed for retention are part of a significant grove.

Photo 1. The trees along the east edge of the existing play field. These trees would be retained as part of the proposed development. Photo taken February 12, 2025.

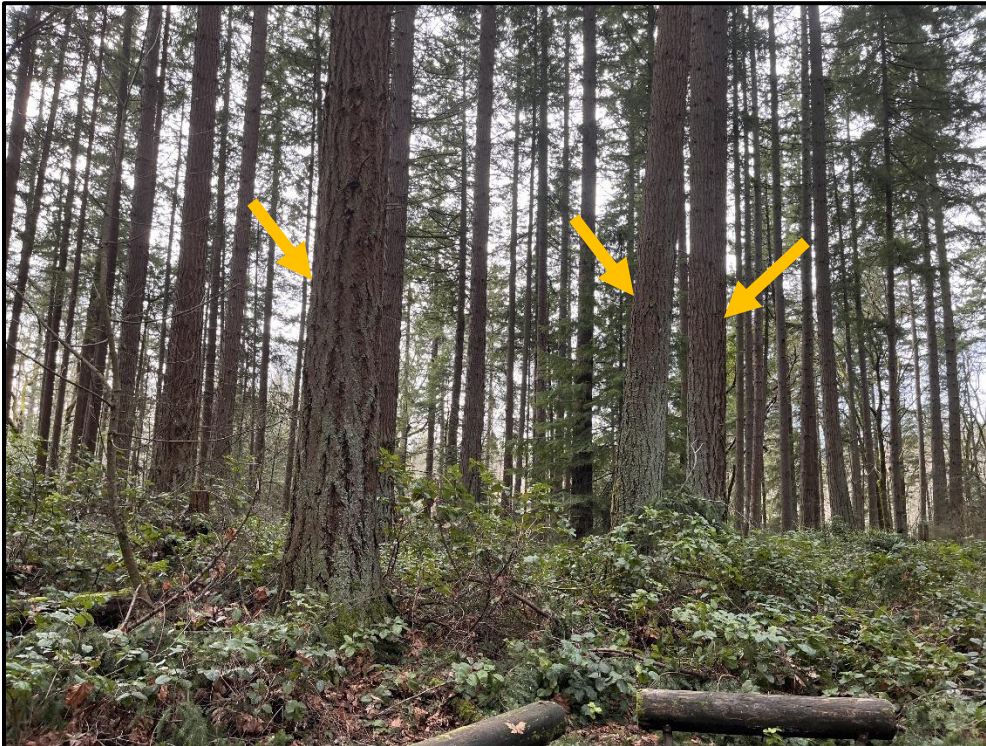
I found the largest specimens of trees on the west and northwest sides of the site (Photo 2). Many of the Douglas-fir trees in this area qualify as exceptional according to the KMC 18.57.063. Overall, the trees in this area were in good to excellent health and good structural condition. These trees would be excellent candidates for retention.

Photo 2. The forest from the interior looking west toward wetland A being prioritized for retention. The three Douglas-fir trees in the foreground are exceptional by size, several others in this area appear to be exceptionally sized as well.

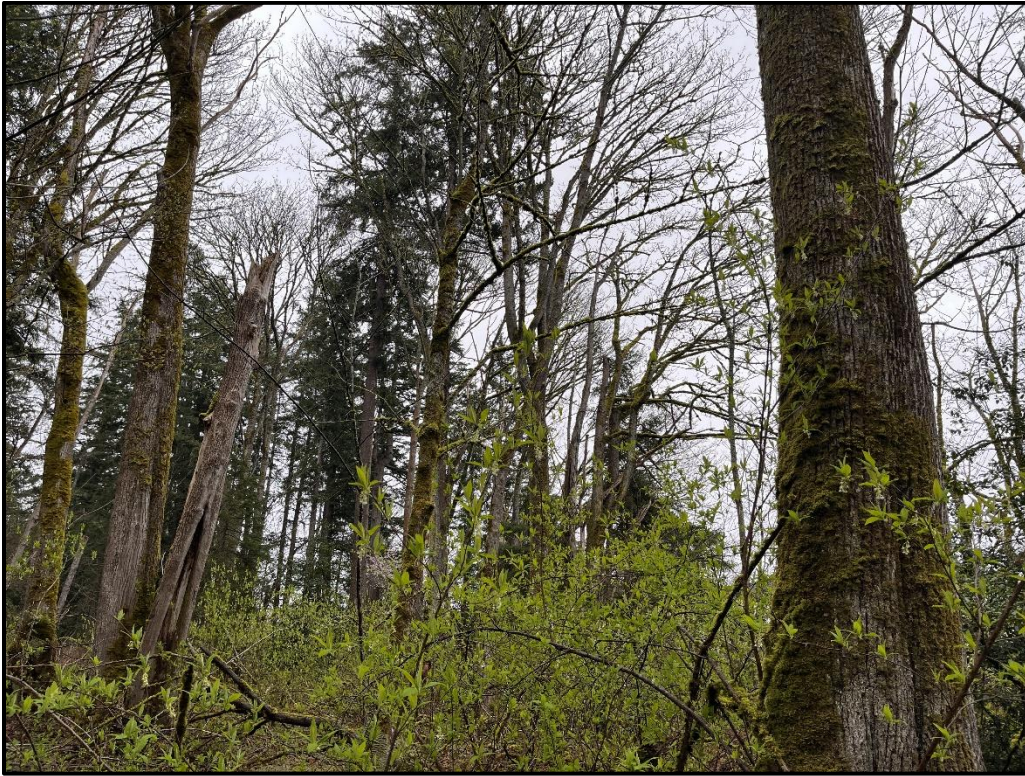
Toward the southwest corner of the forested area toward wetland A there is a broadleaf forest predominantly made up of bigleaf maple (Photo 3). Most of these maples are in mature form with crown breaks and many have decay organisms (Photo 4) that are native to this species and region including brittle cinder fungus (*Kretzschmaria deusta*) and artist's conk (*Ganoderma applanatum*). These conditions are normal for trees of this species and maturity. However, it does affect their suitability for retention during development.

Photo 3. The southwest portion of the forest primarily made up of bigleaf maple in mature condition. These trees did not appear to reach exceptional size and had decay organisms and crown failure present.

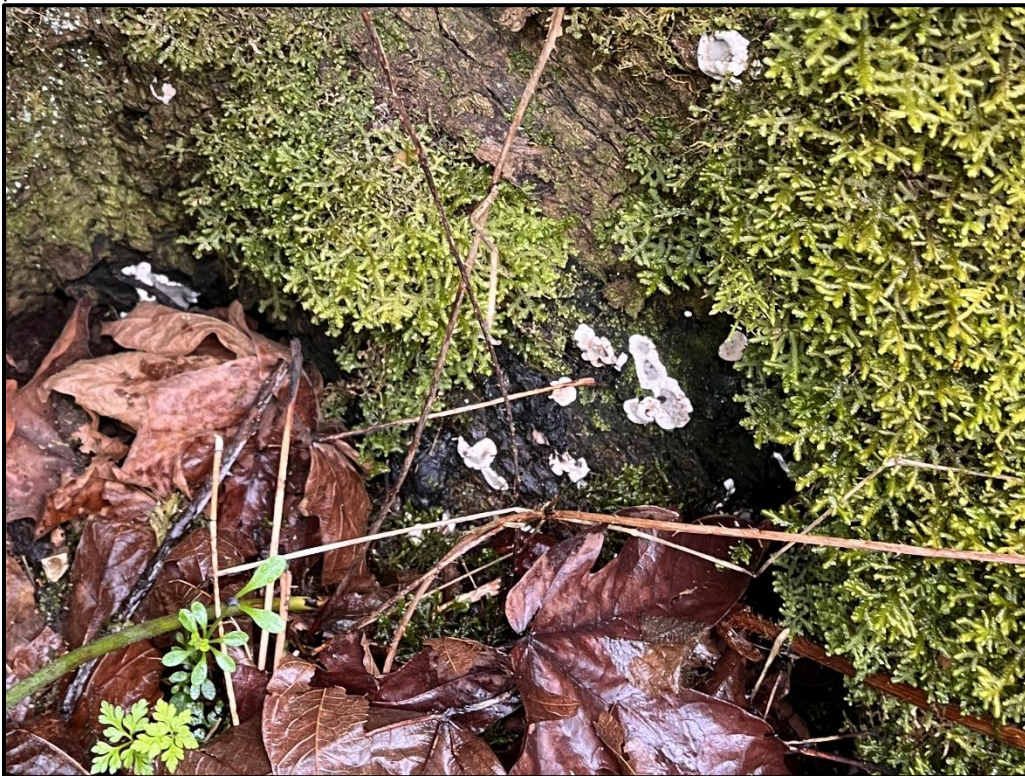
Photo 4. An example of brittle cinder fungus, a decay organism at the base of a bigleaf maple.

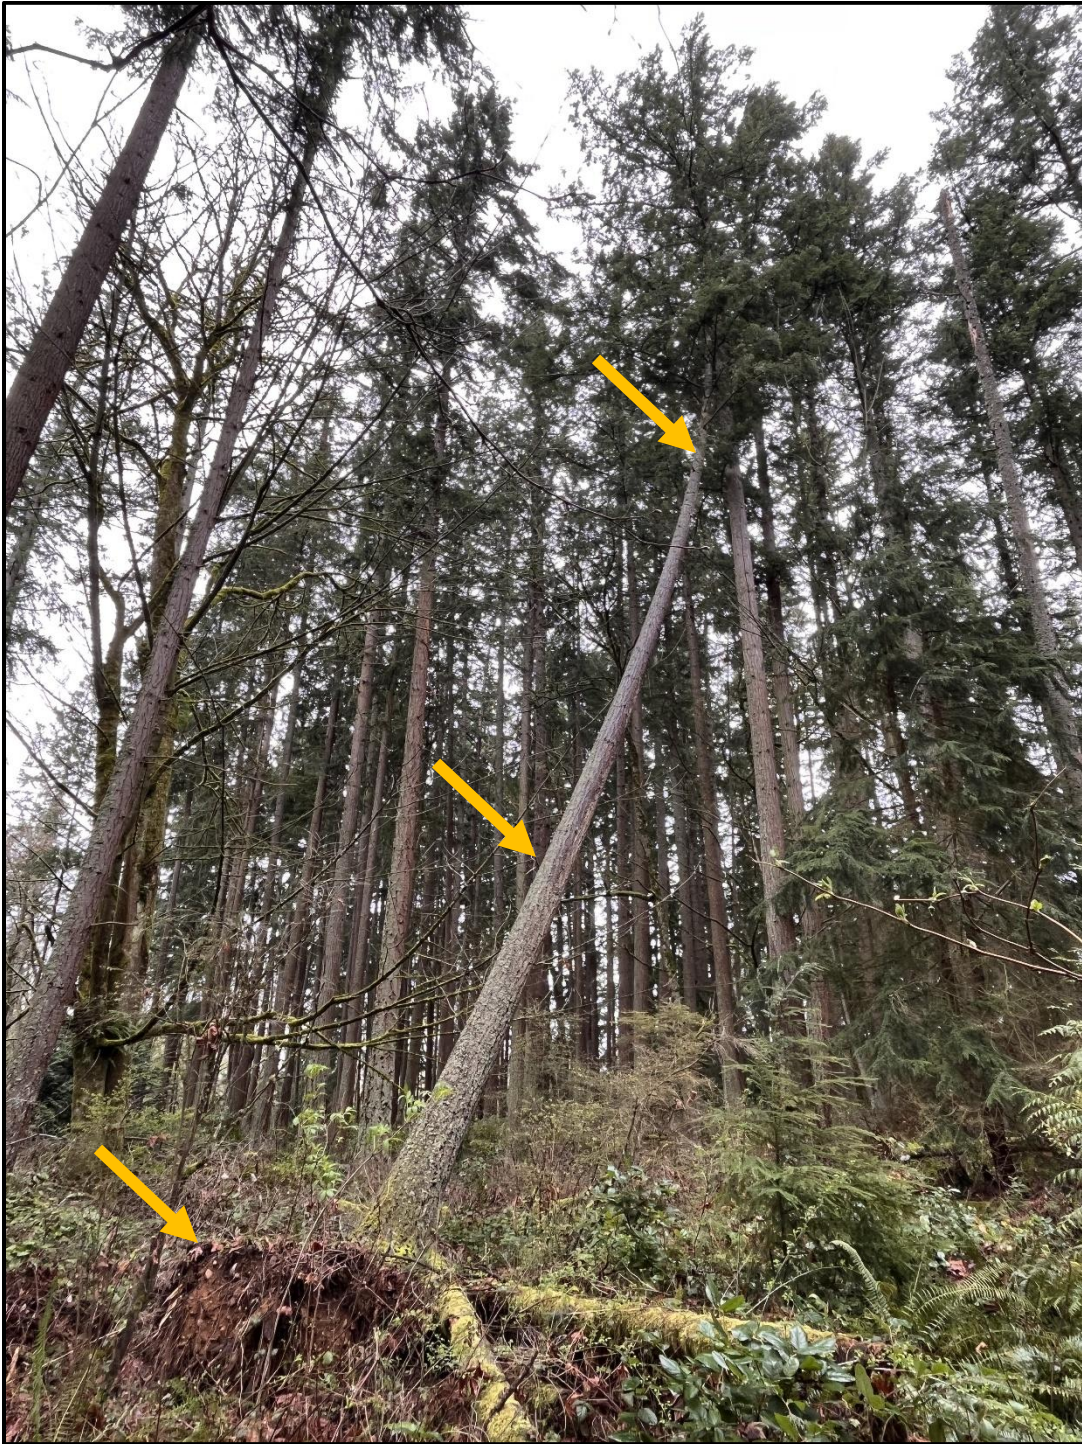
In the south portion of the site, the Douglas-fir trees were smaller on average than in the more northerly and westerly portions of the forest with a lower density of exceptional trees. The trees in this area appear to have also been disturbed by previous construction activities to install an adjacent parking surface and dorms several years ago. Several Douglas-fir trees in this area had failed at the roots (Photo 5, Photo 6) and had a decay pattern consistent with laminated root rot (*Coniferiporia sulphurascens*) (Photo 7). There were also several trees showing symptoms of stress including thinning and dieback in their crowns (Photo 8) and some standing dead trees which are consistent with a laminated root rot (LRR) disease center.

LRR is a fungal decay that affects the root systems of Douglas-fir and western hemlock trees among others. The disease primarily spreads by root grafting creating disease centers in forests where many trees become infected in one area. The crowns of trees typically display symptoms of stress as the root system decays and can no longer efficiently pump water up into the crowns. However, infected trees sometimes show no symptoms of stress. No fungal fruiting bodies are visible on trees with LRR because they grow on the undersides of the roots so they are not visible until they fail. This disease cannot be controlled or eradicated. Therefore, the trees must be managed for risk to surrounding targets like buildings or people.

Photo 5. A recent tree failure at the roots from laminated root rot caught up in another tree.

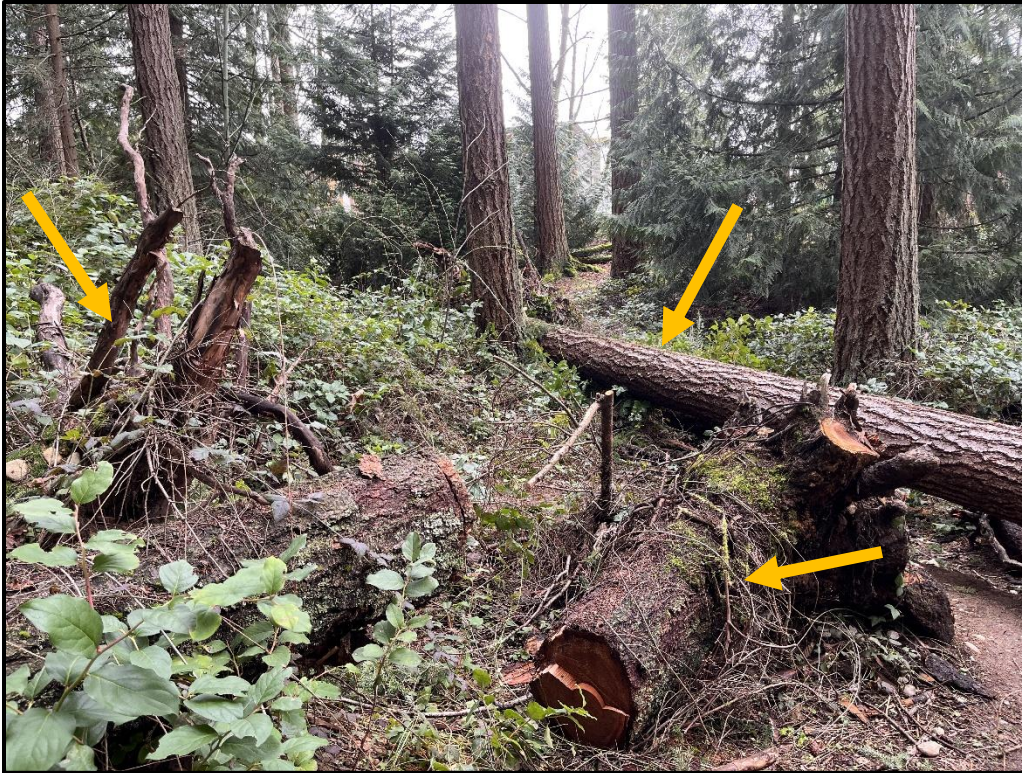
Photo 6. Another example of three trees that had failed as a result of root decay.

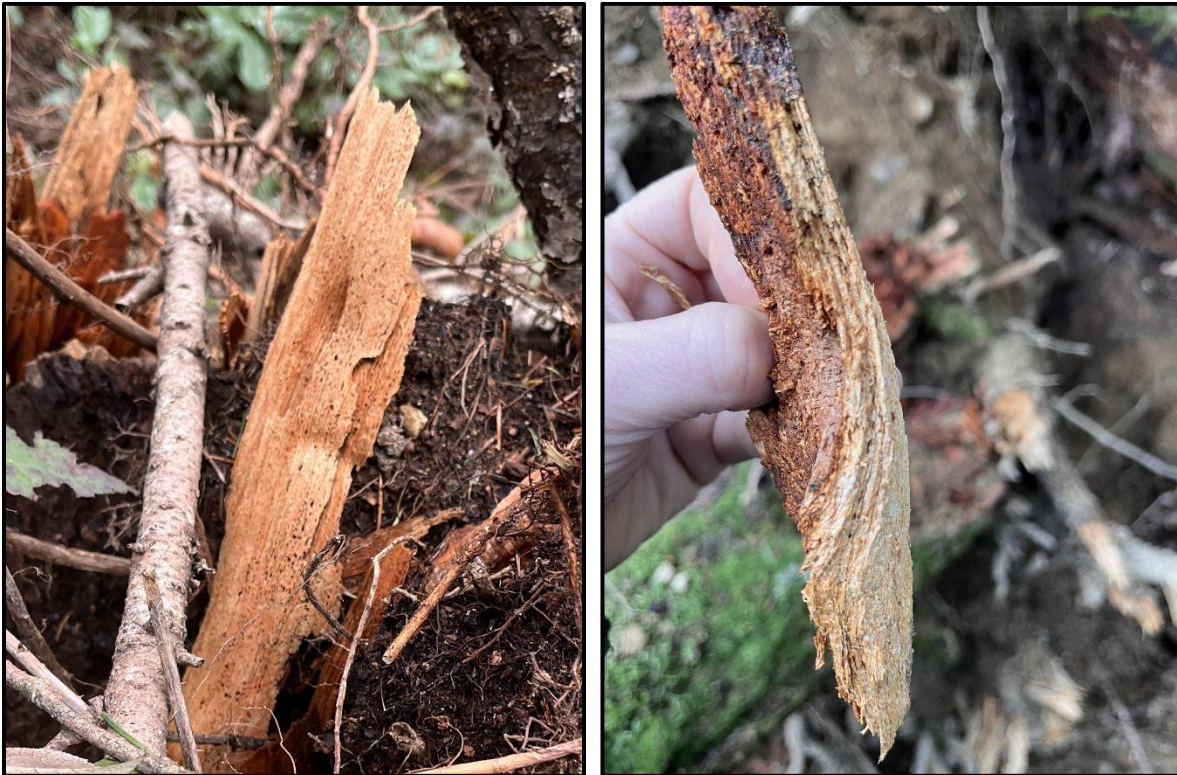
Photo 7. Decay patterns consistent with laminated root rot.

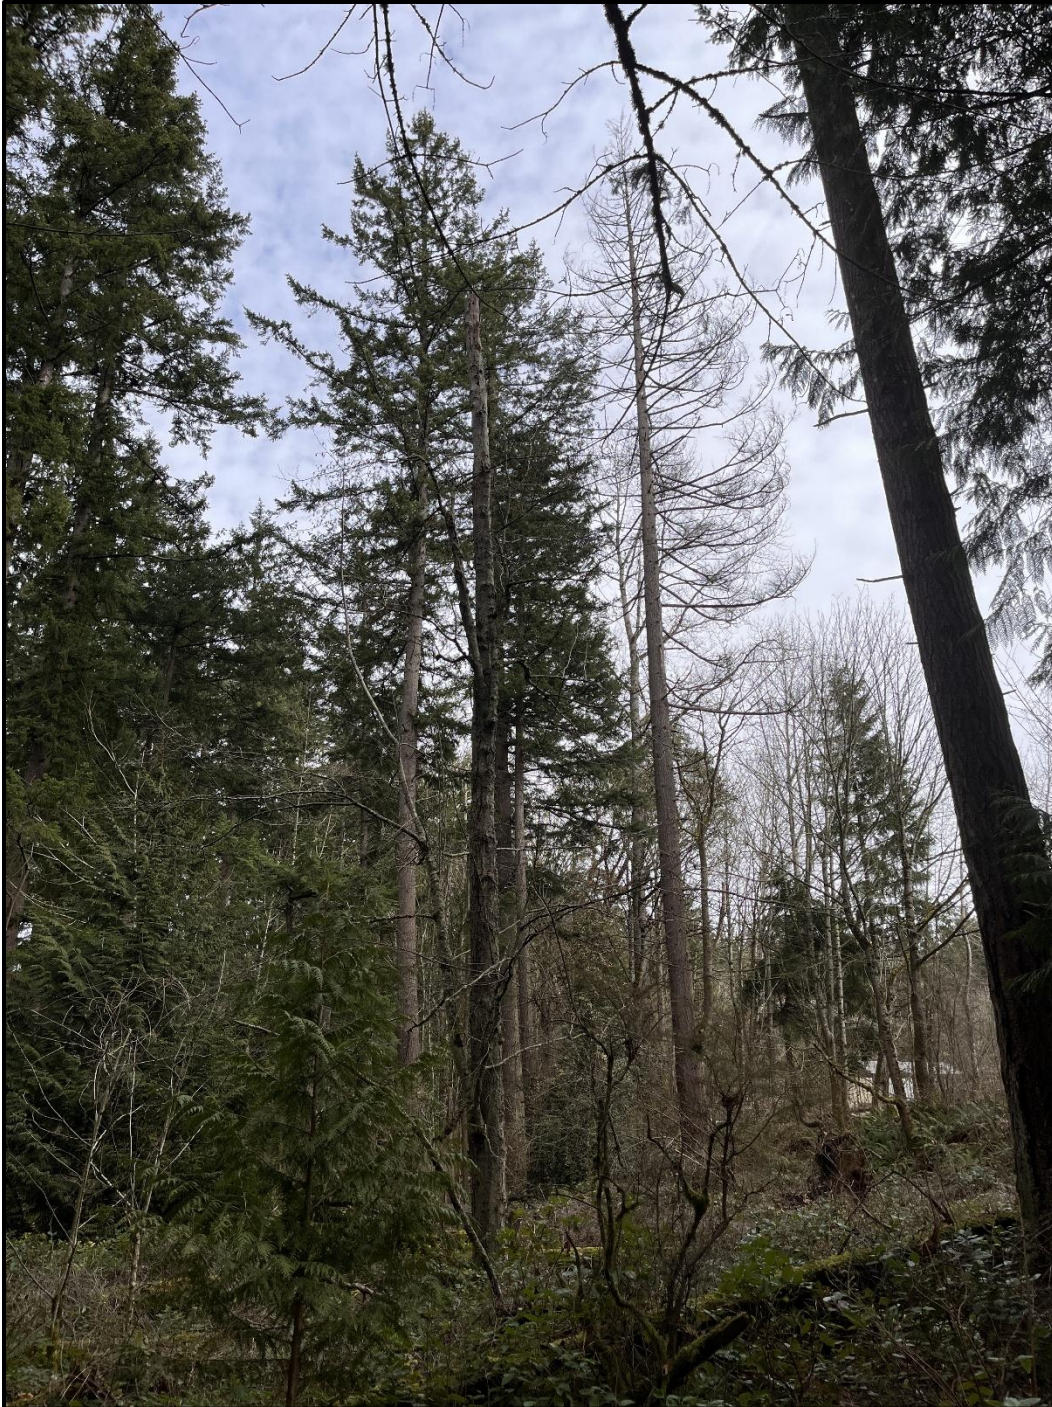
Photo 8. An example of a standing dead tree and an adjacent tree with crown symptoms of thinning and weak shoot extension consistent with root decay.
